Energy Procedia 78 (2015) 164 – 169

6th International Building Physics Conference, IBPC 2015

Analysis of direct and flanking sound transmission between rooms with curtain wall facades

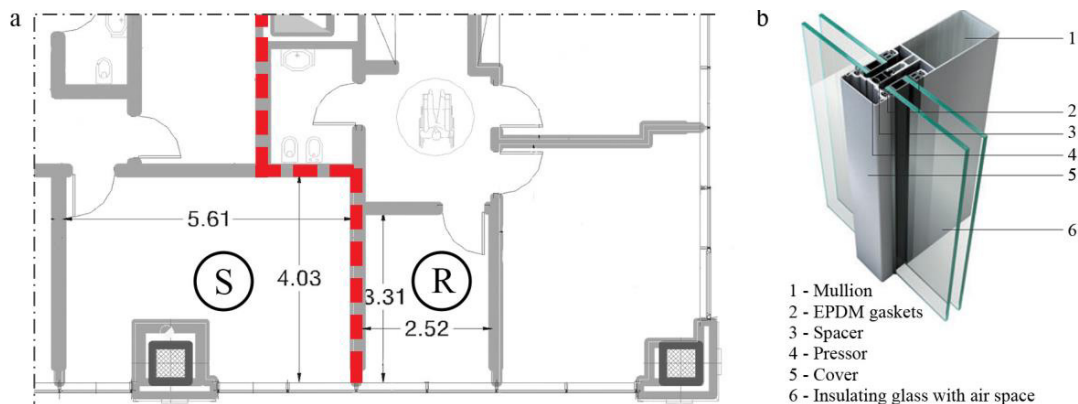
Fig. 1. (a) Plan portion of the building under test where: S = source room, R = receiving room, dashed line is the limit of two distinct properties; (b) detail of the curtain wall structure.

To better characterize the sound transmission through a curtain wall, the Apparent Sound Reduction Index of the partition between the adjoining rooms shown in Fig. 1.a was measured according to the procedure described by EN ISO 16283-1 [6], while velocity vibration measurements were carried out according to EN ISO 10848 [7].

The improvement intervention were realized in the junction between the separating wall and the curtain wall, where the wall thickness was reduced by the architects to allow the opening of the windows of the facade. Moreover, the curtain wall mullion was realized with a single aluminum section (Fig. 1.b).

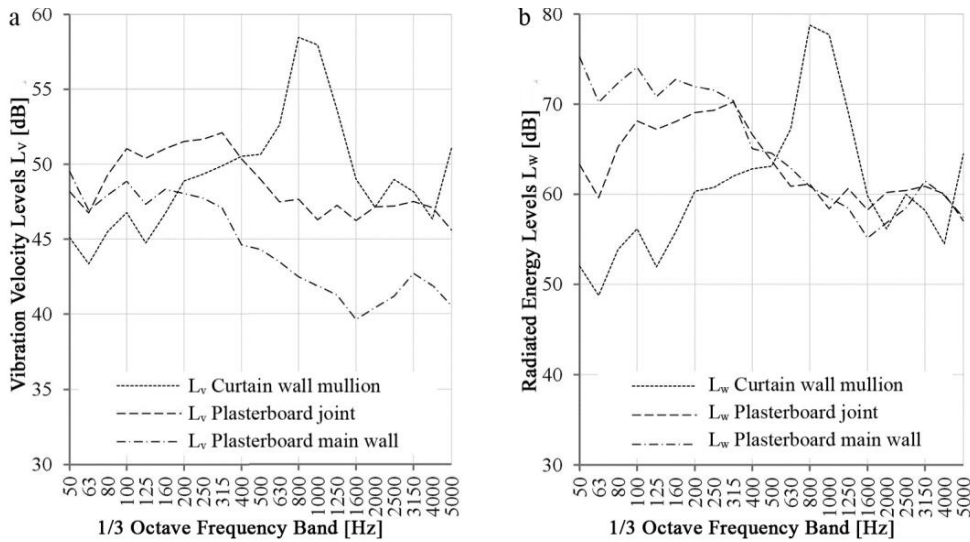
Fig. 2. (a) Measured velocity levels L_v in dB; (b) Estimated radiated energy levels L_w in dB.

Fig. 2.a shows the velocity vibration levels (dB ref. 10^{-6} m/s) of the three structures. Values are shown both as velocity levels (L_v in dB) in Fig. 2.a and as radiated power level (L_w in dB) in Fig. 2.b ($L_w = 10 \log_{10}(W/W_0)$, with $W_0 = 10^{-12}$ W), normalized to respective surfaces; in this comparison we have considered radiation efficiency $\sigma = 1$ at each 1/3 octave band and for all materials. Radiated power is calculated as follows:

Fig. 2 shows two main paths of sound transmission: transmission through the aluminum mullion of the curtain wall, and transmission through the reduced thickness plasterboard joint (three plasterboard layers directly connected to each other, see Fig. 4.a). It is clear that the sound insulation gap at 1000 Hz is due to the mullion of the curtain wall, although it has the smaller surface, compared to other components.

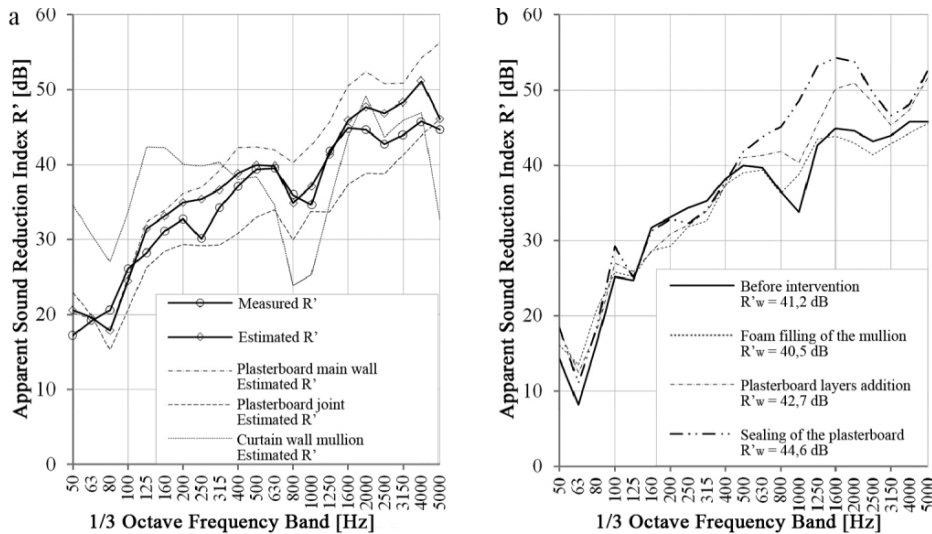
Fig. 3. (a) Graph of the Apparent Sound Reduction Index, R' , measured (EN ISO 16283-1:2014) and estimated with EN 12354-1, Appendix B.1 method. R' estimations for each element composing the wall are reported as well. (b) Graph of the Apparent Sound Reduction Index R' before (continuous curve) and after the interventions.

R' curve (Fig. 3.b) shows an irregular behavior around 1000 Hz: this kind of performance drop is usual to be expected around 2500-3150 Hz, which is the average coincidence frequency for plasterboard wall [9].

Using the approximations above explained, R' was calculated from the measured vibration velocity and compared to R' measured with EN ISO 16283-1 method. Only velocities measured over the main wall components were considered, due to the fact that flanking components have an average of 5÷10 dB lower L_v . Despite the approximations in the calculation of the radiation efficiency, a good agreement between the two R' curves is shown in Fig. 3.a. The continuous curve is R' estimated using the EN 12354-1 hypothesis; empty dots are the ISO 16283-1 measurement's values.

In spite of this, the apparent sound reduction index only increases at mid and high frequencies, as the graph in Fig. 3.b shows. This fact is due to different problems of the separating wall but mainly to the structural sound transmission through the metal mullion of the curtain wall. Moreover an increasing in the coupling between receiver and source side of the vertical aluminum mullion could be caused by the polyurethane foam filling: despite a lower dip at 800 and 1000 Hz, a wider frequency range, between 160 and 400 Hz, is affected by a significant worsening of the performance. This problem is only partially solved when a new plasterboard layer was added and sealed (dash-dot-dot line in Fig. 3.b).

Fig. 3.b shows that the lining of the vertical mullion of the curtain wall at the junction with the separating wall causes an average $3\div15$ dB increasing of the apparent sound reduction index R' , at mid and high frequencies. The difference is instead not significant at lower frequencies where the resonance of the lining system described in Fig. 3.b reduces the acoustic performance of the partition. In particular it is interesting to note that the lining of the frame eliminates the insulation drop at 1000 Hz, which is probably due to a resonance of the mullion of the curtain wall. A similar problem was shown also in a previous study on this kind of junction [2].

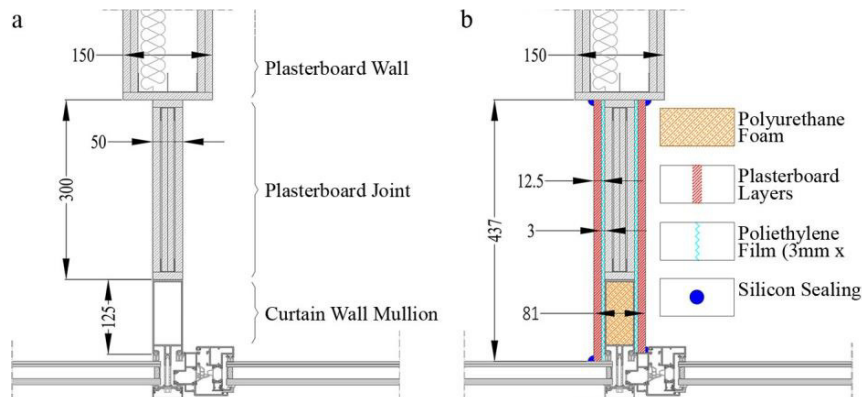
Fig. 4. The junction between the separating wall and the curtain wall before (a) and after (b) the improvement intervention. Dimensions are in mm. The main wall has a 5 cm mineral wool layer and an air gap of 5 cm.

Velocity level measurements were carried out using 2 grams mono axial accelerometers, randomly placed over the surfaces. Plasterboard main wall, plasterboard joint and metal curtain wall mullion, illustrated in Fig. 4.a, were first analyzed. Other flanking noise paths (floor, glazing, ceiling) were investigated too, but they had much lower velocity levels, compared to those measured over the main wall. In consideration of this fact, velocity levels for flanking components are omitted for brevity.

The intervention was limited by the need not to increase the wall thickness more than 2 cm per side, to allow the opening of the windows. Two layers of closed-cell polyethylene film 3 mm thick and a layer of plasterboard on each side of the separating wall were applied (Fig. 4.b). Furthermore, the vertical mullion of the curtain wall was filled with polyurethane foam.
